Manhole Inspection Summary

Manhole # S27M__024MH

Insp Date: **5/5/08 12:43 PM**

Location Address: **1209 Ward St**

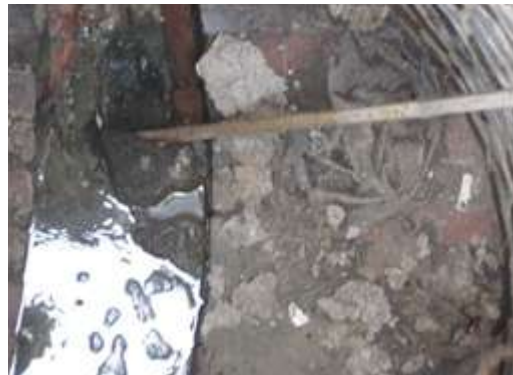
Defect 3

Condition: ☐ Sound ☐ Cracked ☐ Root Intrusion ☐ Deteriorated ☐ Leaks ☒ **Debris**

channel and bench cond debris

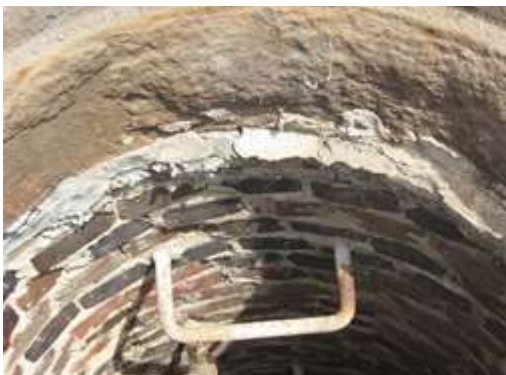
Defect 2

corroded steps

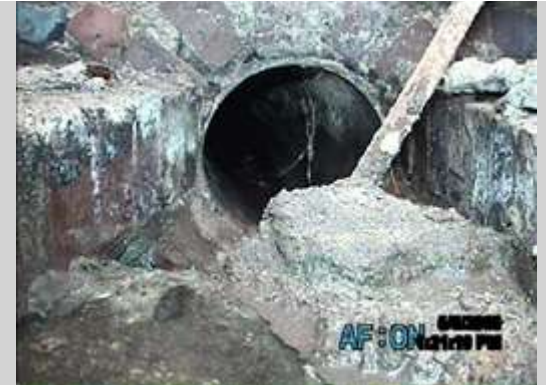
12 O'Clock Outflow

8 in. Circular Gravity Sewer
Pipe Out @ 12 O'Clock

Deposits: ☒ None ☐ Mud ☐ Sludge ☐ Debris ☐ Grease

Infiltration: **None** Pipe Seal Cond: **Sound**

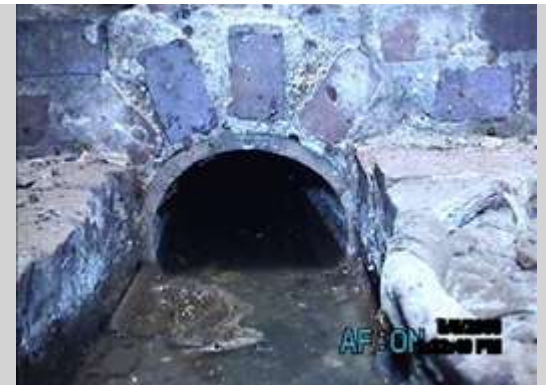
6 O'Clock Inflow

8 in. Circular Gravity Sewer
Pipe In @ 6 O'Clock

Deposits: ☒ None ☐ Mud ☐ Sludge ☐ Debris ☐ Grease

Infiltration: **None** Pipe Seal Cond: **Sound**
